## **Realistic Safe-Separation Distance Determination for Mass Fire Hazards**

by  
Thomas L. Boggs  
*New Directions Technology, Inc.*  
*Ridgecrest, CA 93555*

**MARCH 2013**

NAVAL AIR WARFARE CENTER WEAPONS DIVISION  
China Lake, CA 93555-6100

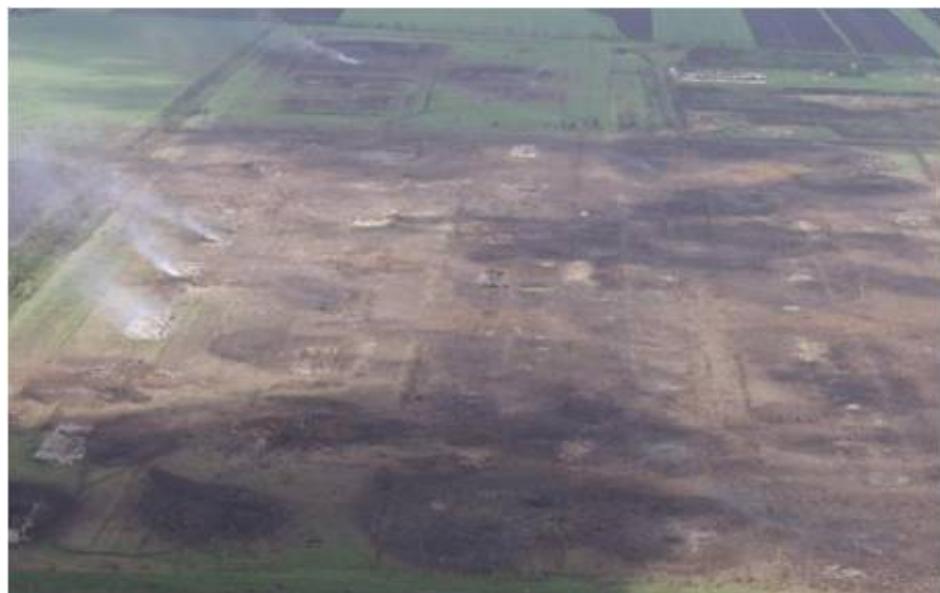
FIGURE 35. Novobogdanovka, Ukraine, After May 2004 Accident.

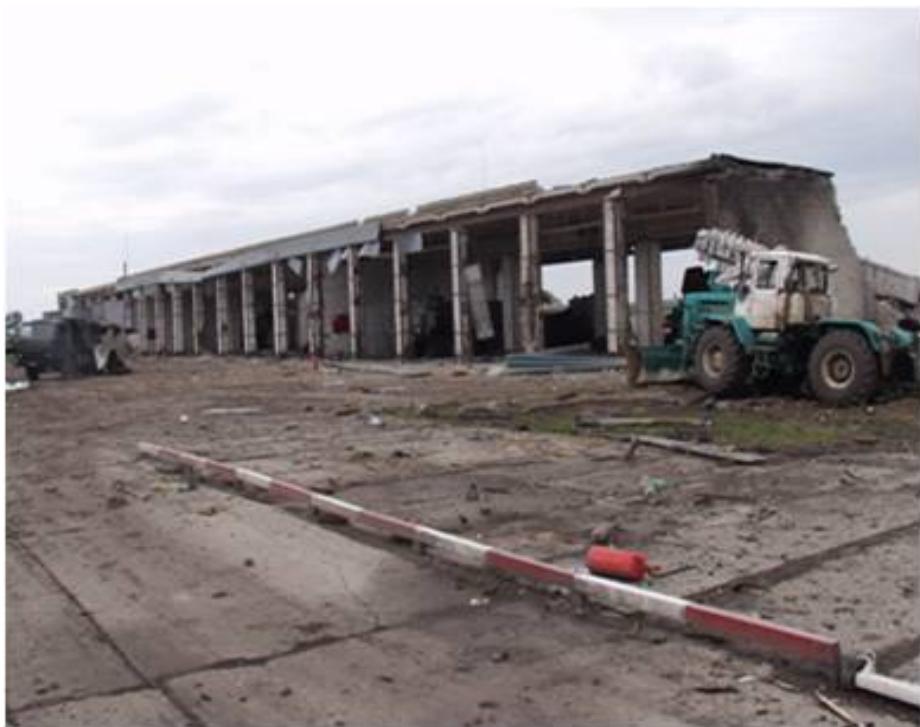
FIGURE 36. Devastation of Facilities and Equipment at the 275<sup>th</sup> Ammunition Base, Novobogdanovka, Ukraine.

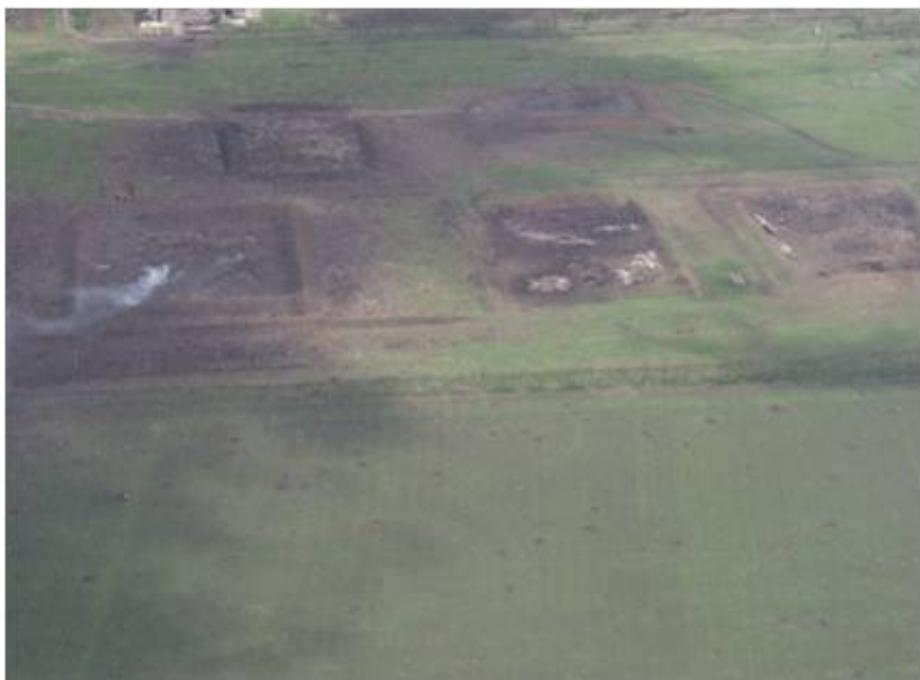
FIGURE 37. Aerial View Showing Some of the Devastation at the 275<sup>th</sup> Ammunition Base, Novobogdanovka, Ukraine.

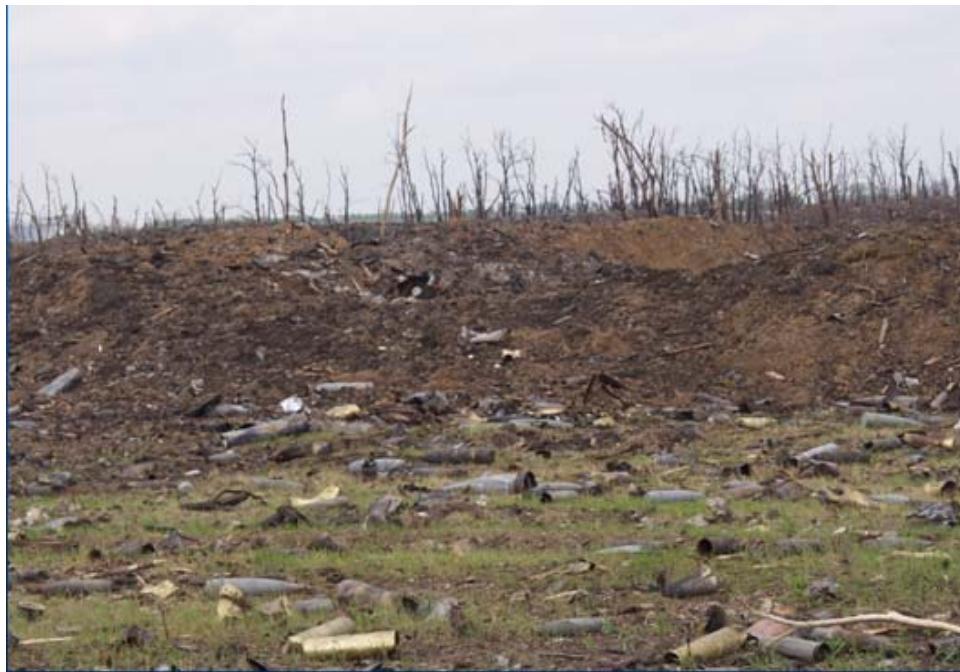
FIGURE 38. View of Devastation and Dispersion of Munitions and Debris at the 275<sup>th</sup> Ammunition Base, Novobogdanovka, Ukraine.

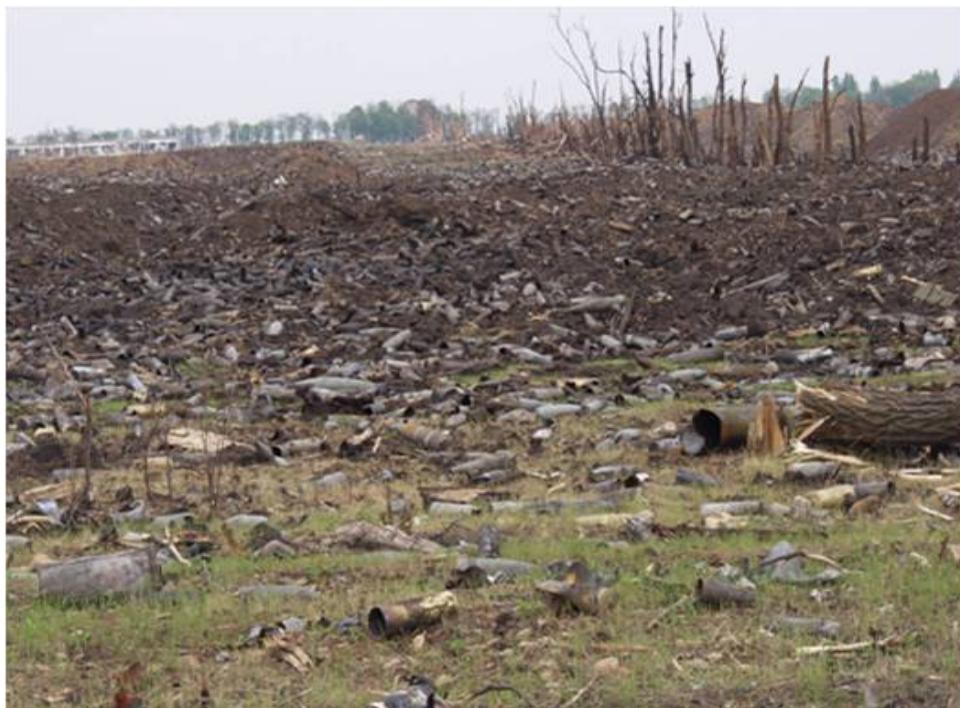
FIGURE 39. View of Devastation and Dispersion of Munitions and Debris at the 275<sup>th</sup> Ammunition Base, Novobogdanovka, Ukraine.

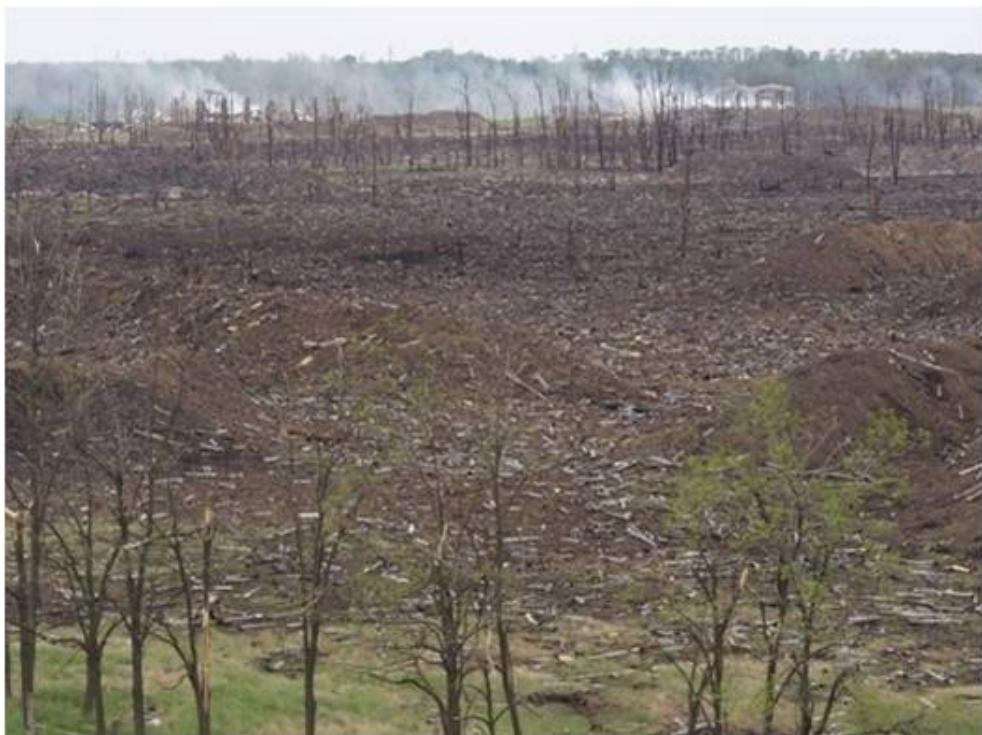
FIGURE 40. Aerial View of Devastation and Dispersion of Munitions and Debris at the 275<sup>th</sup> Ammunition Base, Novobogdanovka, Ukraine.

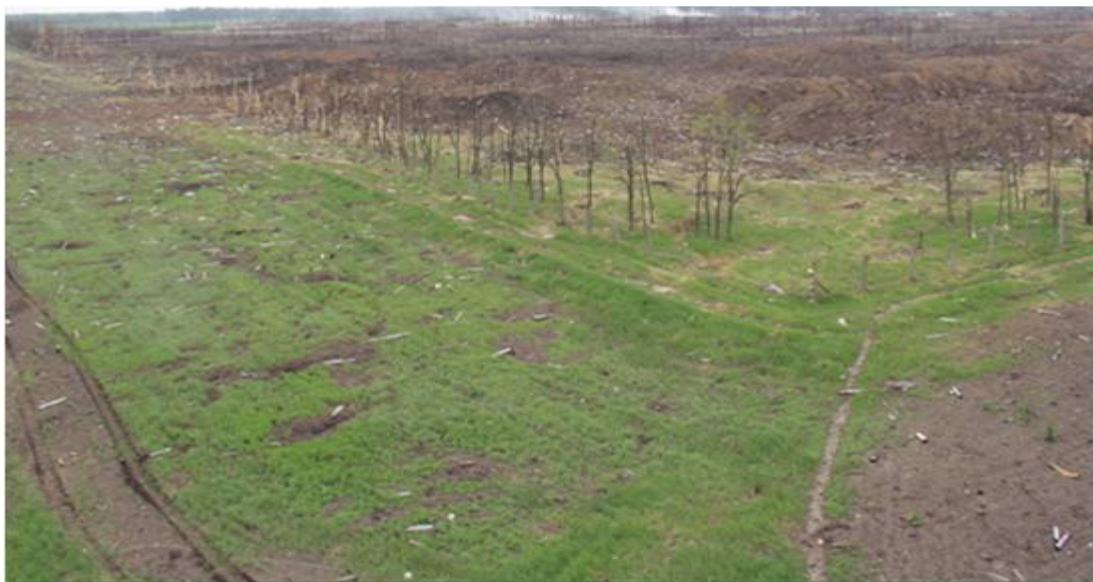
FIGURE 41. Aerial View of Devastation and Dispersion of Munitions and Debris at the 275<sup>th</sup> Ammunition Base, Novobogdanovka, Ukraine.

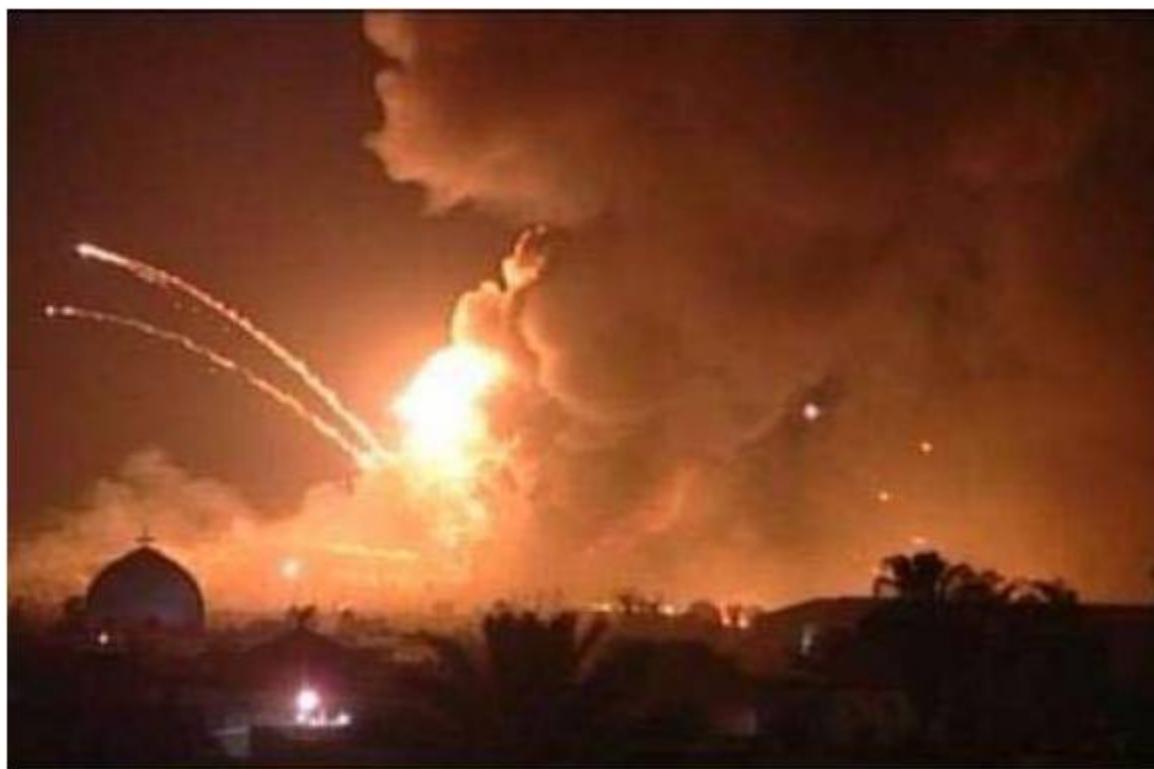
At about 9:00 p.m., a rocket attack caused fires near the ammunition dump at the U.S. air base at Kirkuk, Iraq. The fires spread and caused several explosions over the next few hours. The fires were finally put out at approximately 5:00 a.m. The following morning, there were no casualties on base, but the explosions caused damage over a wide area, including shattered windows and damaged cars. Debris was found 1.5 kilometers from where the munitions were stored. Figure 42 shows the conflagration.

FIGURE 42. Conflagration at Kirkuk U.S. Airbase, Iraq, 2 June 2004.

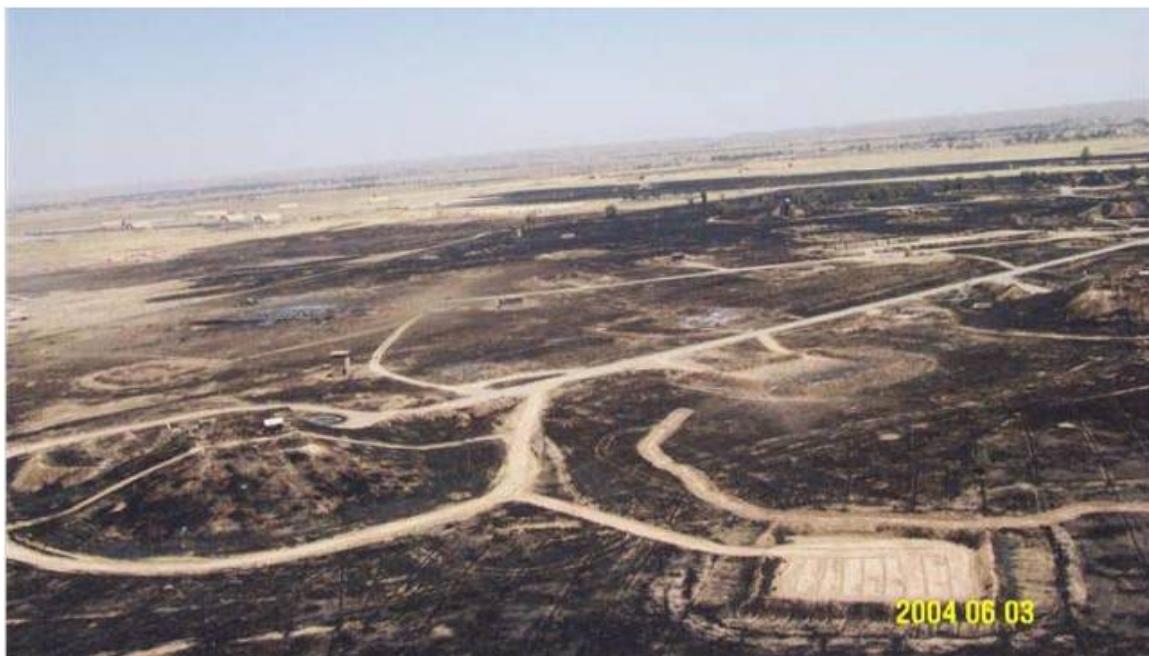
FIGURE 43. Damage to the Kirkuk Airbase After the Fire and Explosions of 2 June 2004.

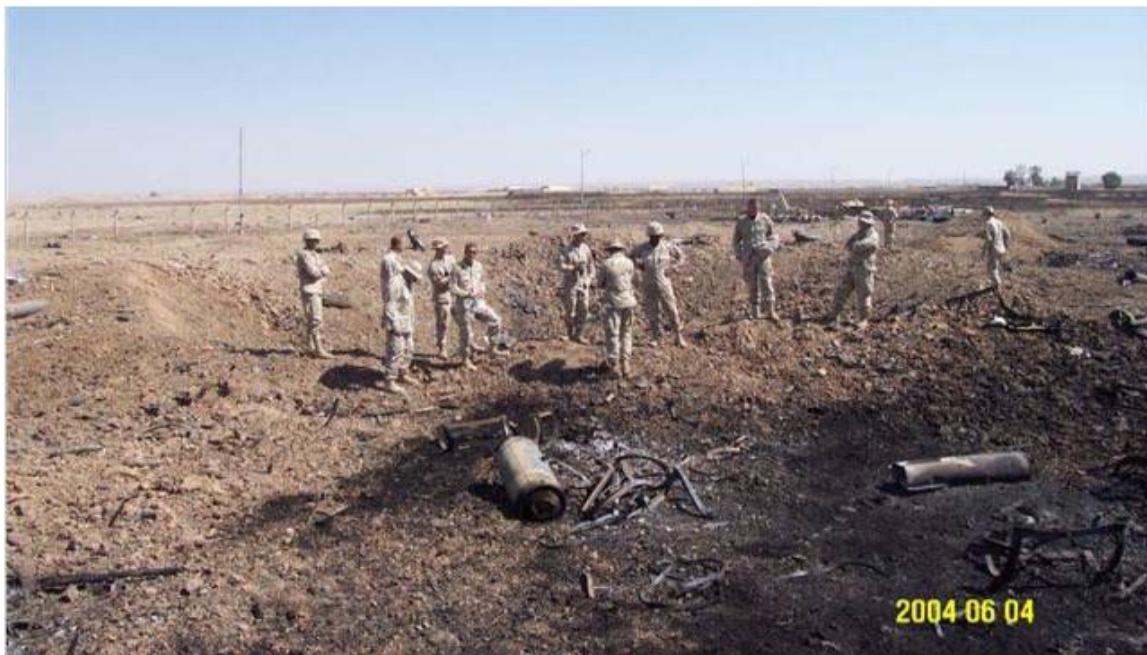
FIGURE 44. Crater Evidence of the Violence of Reactions  
Occurring at Kirkuk Airbase, 2 June 2004.

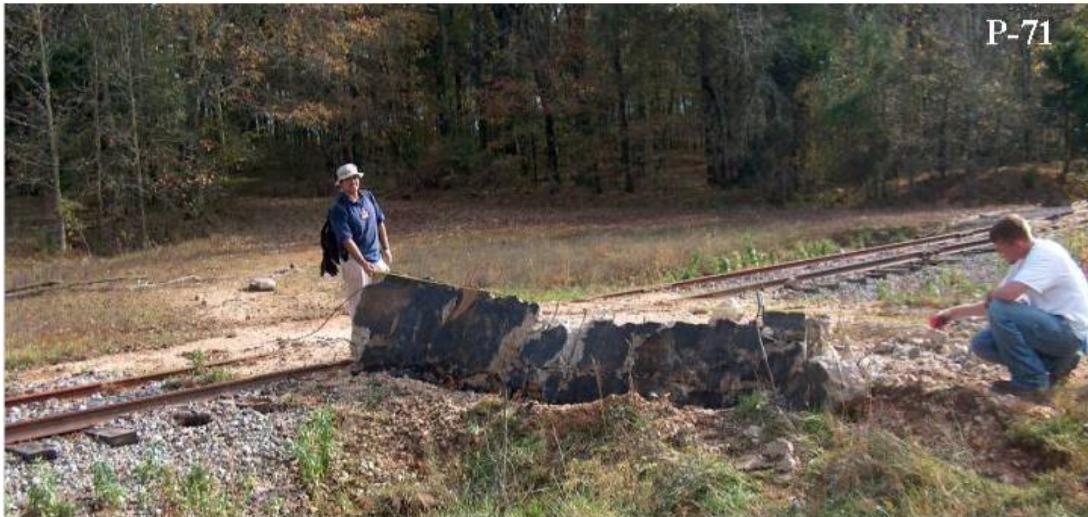
Of particular interest was the size of some of the debris and the distances it was thrown. For example, one fragment was steel reinforced concrete 16 feet in length and 3 to 4 feet in width (Figure 45).

FIGURE 45. Large Fragment That Landed Between Magazines P-70 and P-71.

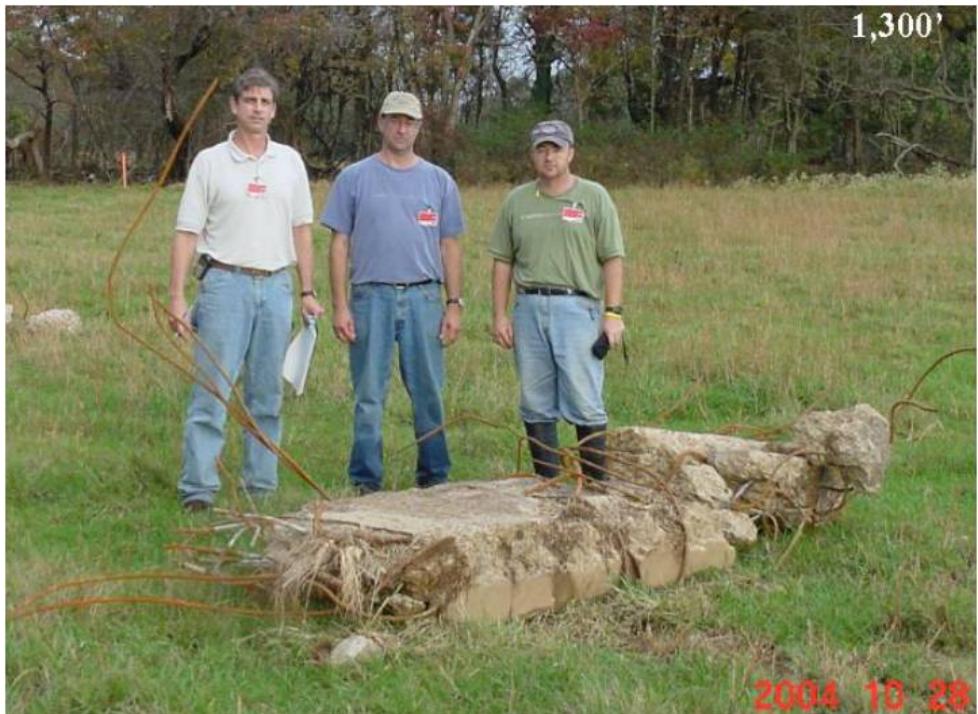
FIGURE 46. Large Fragment That Had Been Part of the Head Wall.  
It was found approximately 1,300 feet from the magazine.

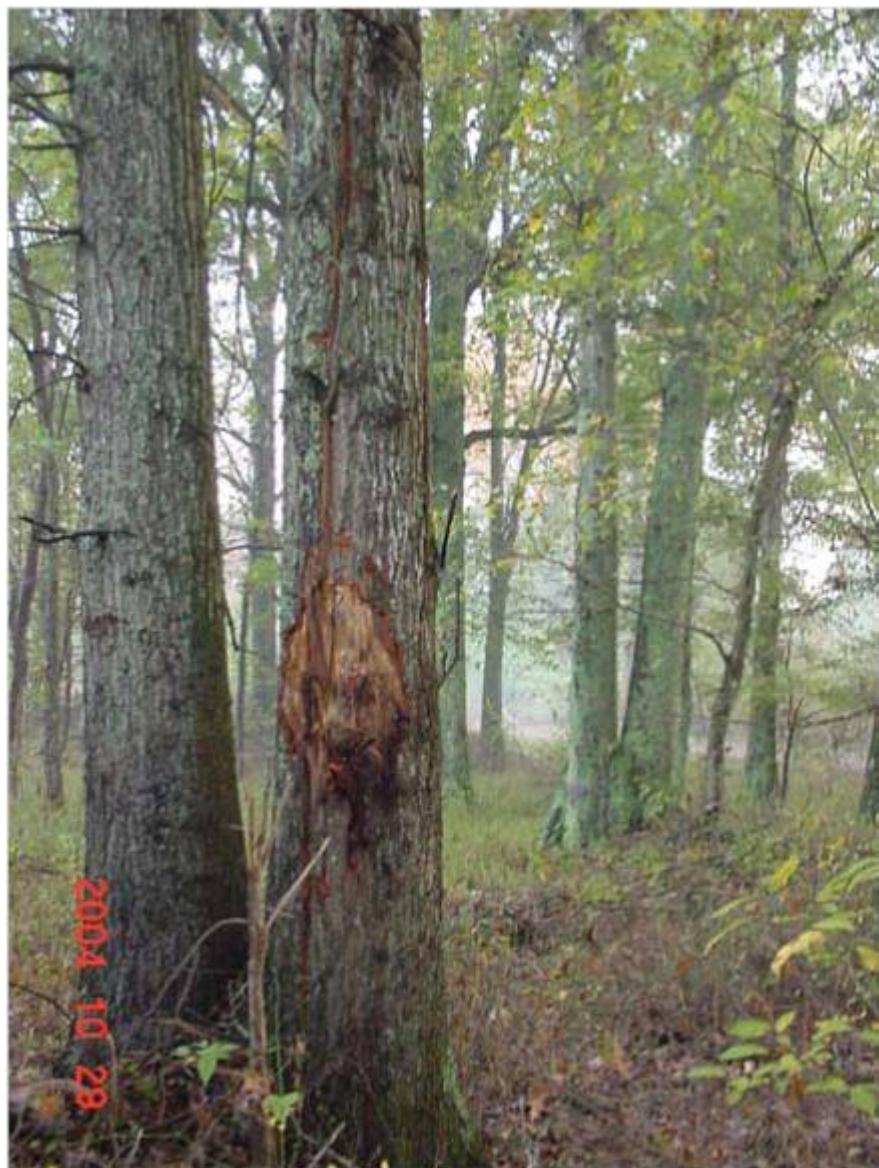
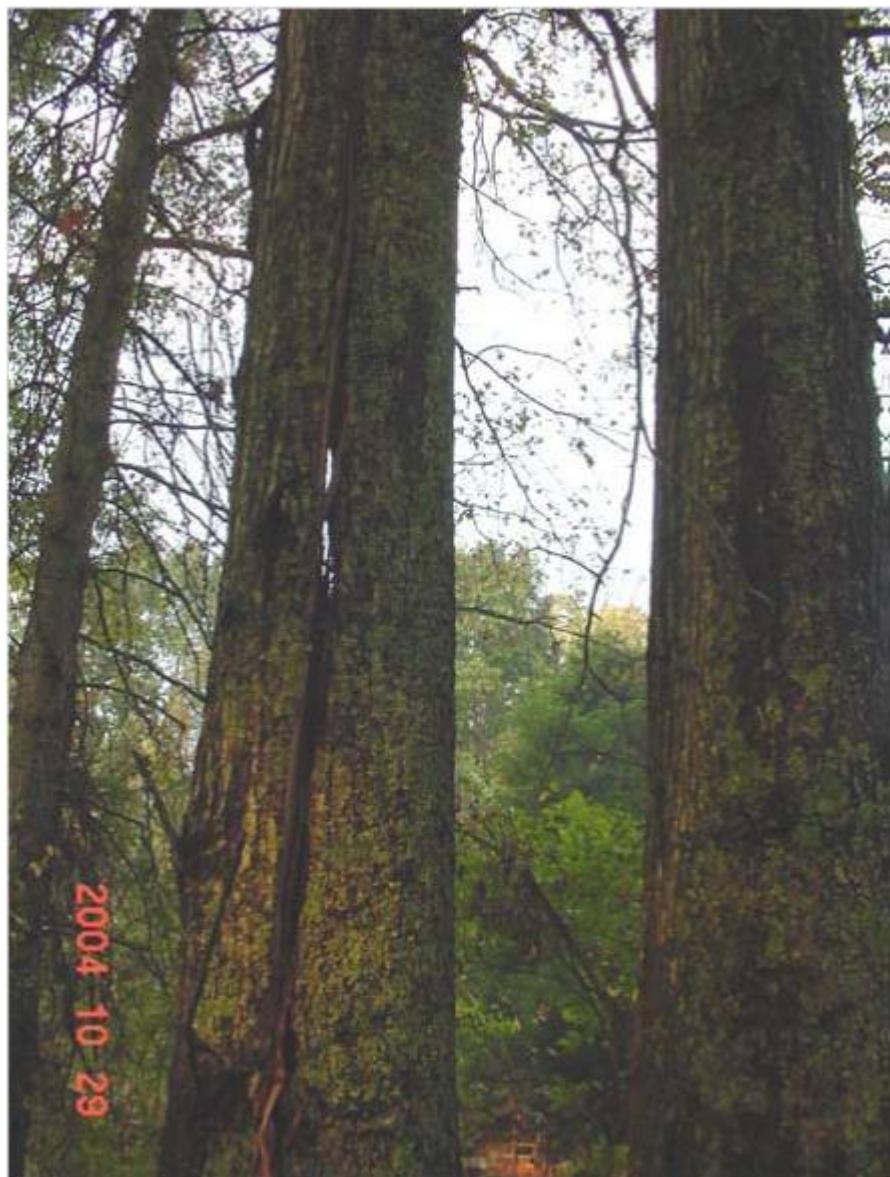
(a) Tree impacted by debris shown in (c).

FIGURE 47. Tree Impacted by Debris.

(b) Another view of the tree showing damage.

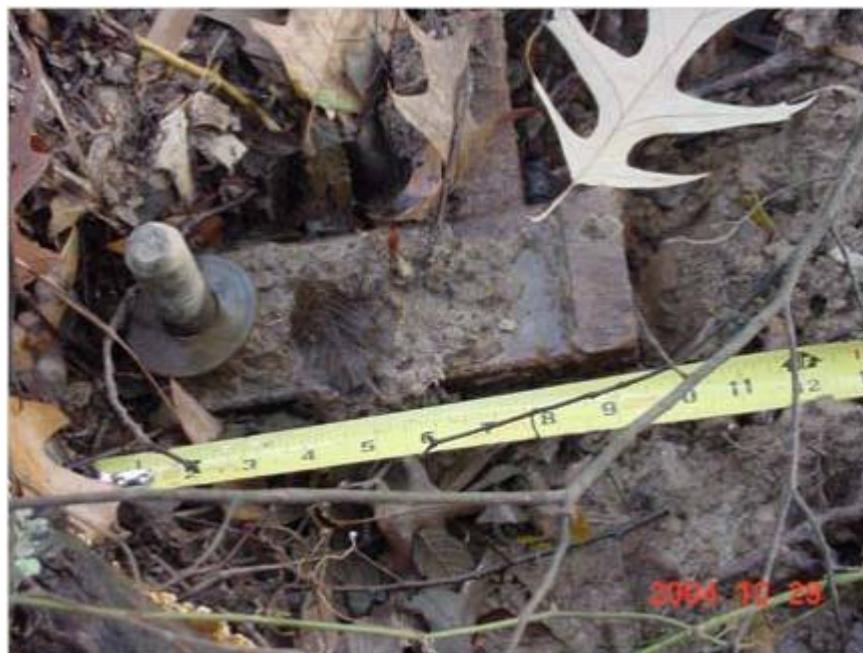
Some of the debris resulted from large fragments breaking up into smaller fragments on impact. There was also evidence of significant fragments traveling distances significantly greater than the 1,250-foot radius IBD arc (Figure 46). For example, there was significant damage to a tree located 2,100 feet in front of ECM-69, as shown in Figure 47 that presents photographs of the tree and the debris found at the base of the tree.

(c) Debris that caused the damage to tree located 2,100 feet to the front of ECM P-69.

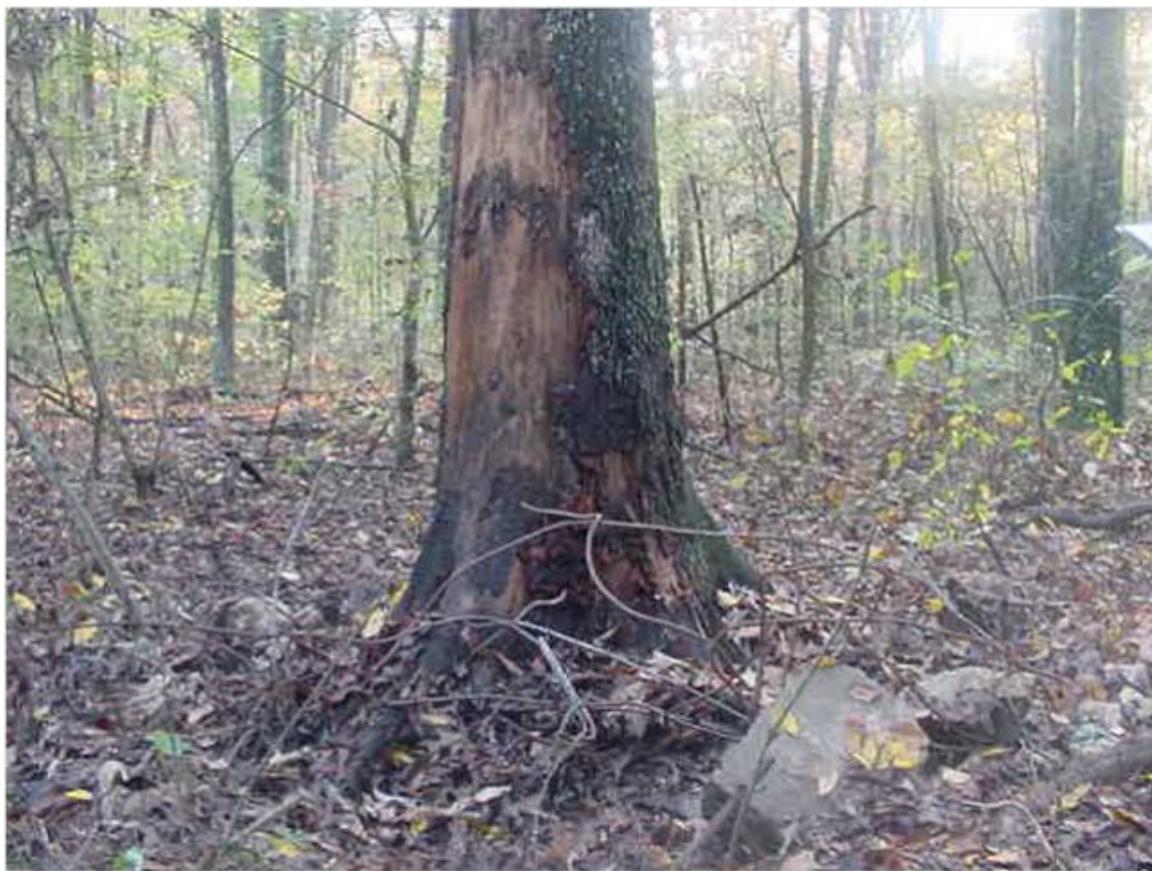
Other debris estimated to have been a 6- by 8-foot section from the head wall significantly damaged a tree 3,100 feet from ECM-69 shown in Figure 48. Obviously, this is well beyond the 1,250-foot IBD arc.

FIGURE 48. Tree Approximately 3,100 Feet From P-69 That was Impacted by an Estimated 6- by 8-Foot Section From the Head Wall of P-69.

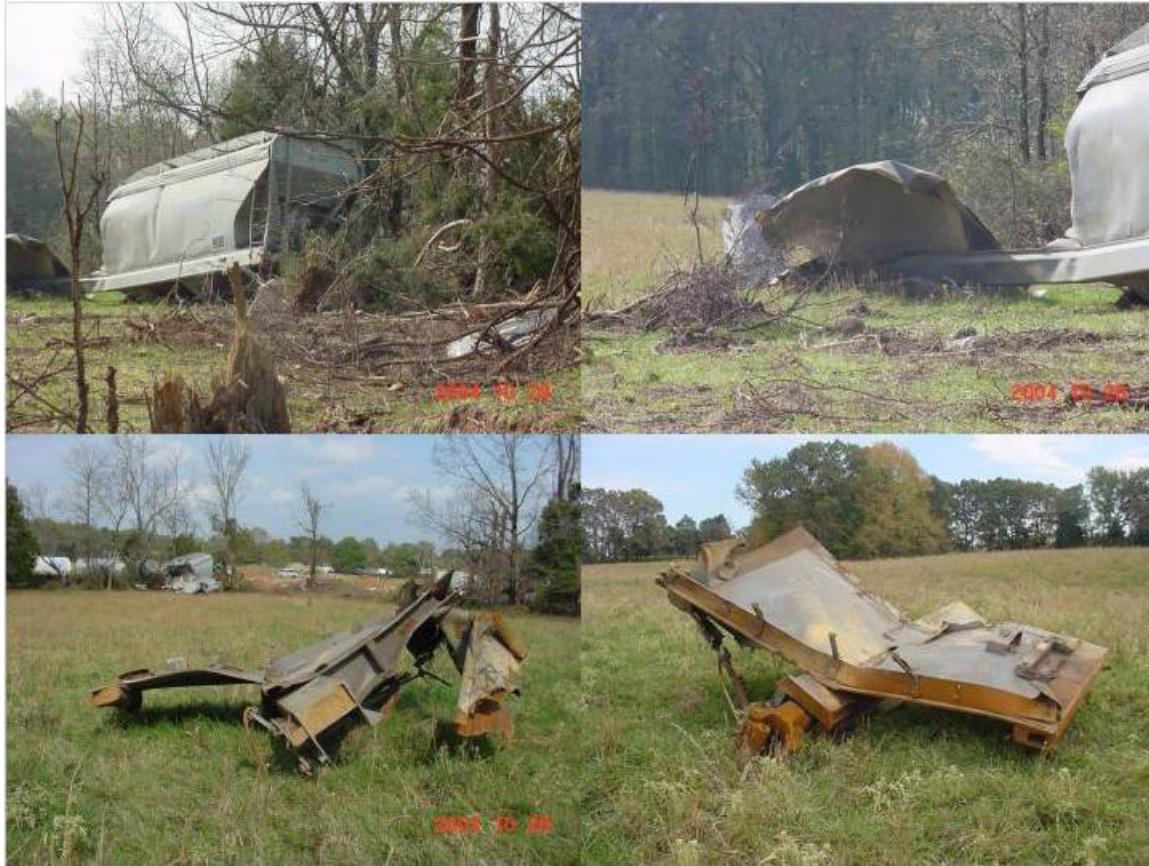
In addition to fragments from ECM-69, there was also damage to railcars. The railcar pictured in Figure 49 was located on the rail line that serviced ECM P-69. As shown in Figure 49, there was significant damage to the railcar and many large steel fragments were torn from it and projected long distances.

FIGURE 49. Railcar That Had Been Located on Rail Line That Serviced ECM P-69.

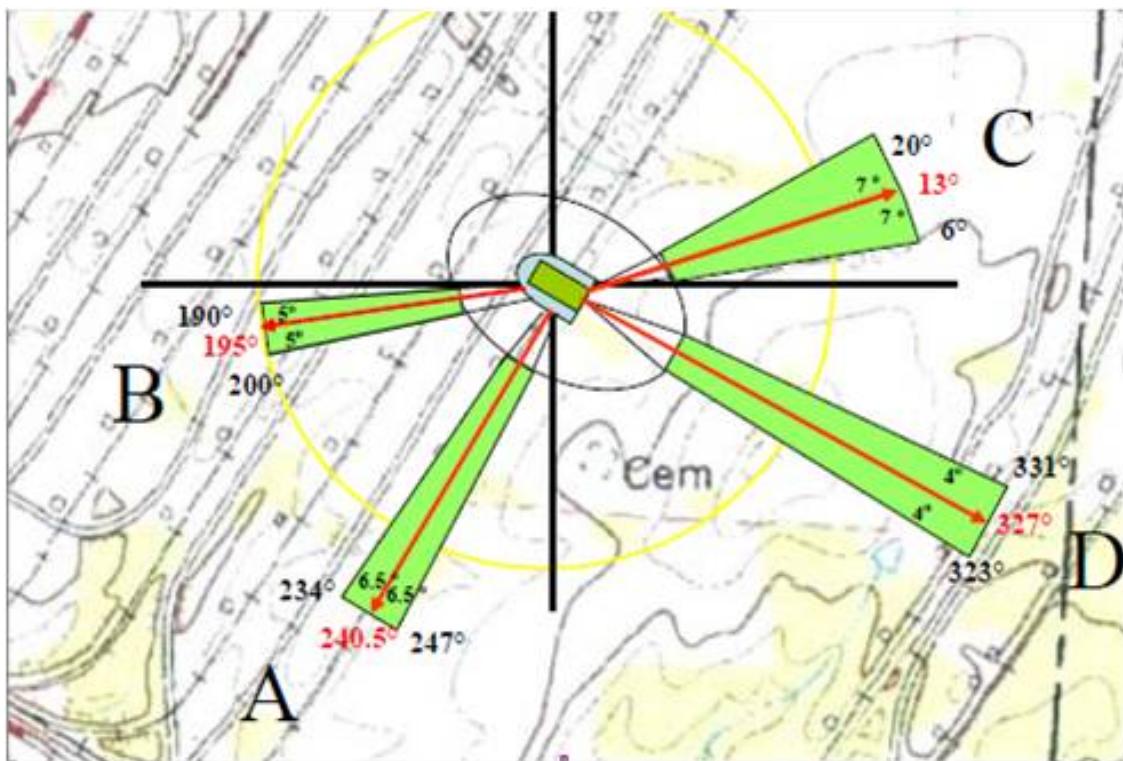
The U.S. Army Technical Center for Explosives Safety initiated an effort to study the debris fields and dispersion of fragments (Reference 23). Four sectors were defined and fragments were mapped and weighed within the sectors. The sectors were an 8-degree wide sector extended from the center of the front of the magazine (Sector D), a 13-degree wide sector from the side of the magazine (Sector A), a 10-degree wide sector about midway between the side and back of the magazine (Sector B), and a 14-degree wide sector midway between the front and opposite side of the magazine (Sector C) as illustrated in Figure 50.

FIGURE 50. Search Sectors.

- The use of unit count indicates excessive hazardous fragment density beyond the 1,250-foot IBD arc in one sector (A).
- The use of weight-equivalent count indicates excessive hazardous fragment density beyond the 1,250-foot IBD arc in three sectors (A, C, and D).

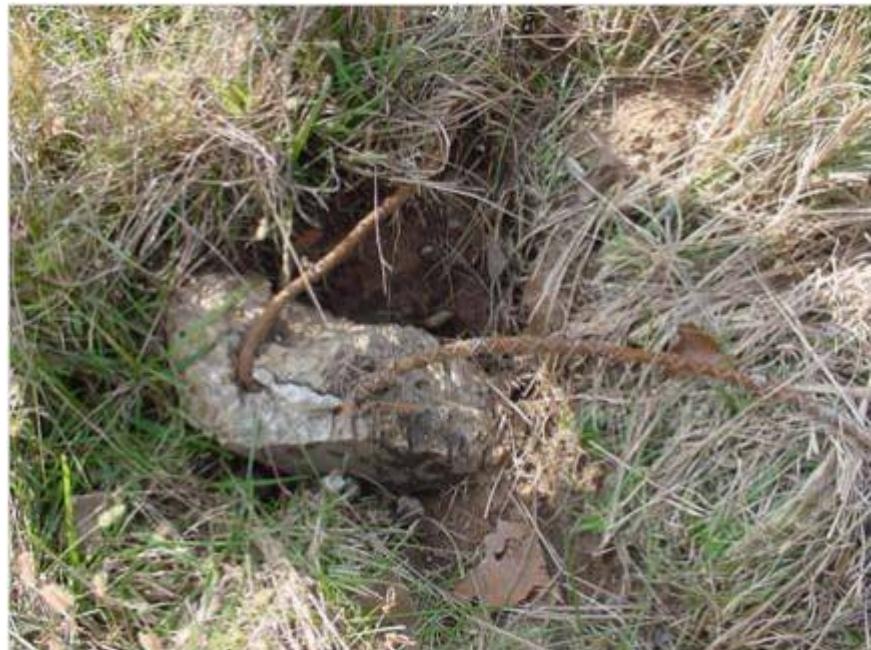
In addition to the sectors previously described, the investigators recorded notable fragments outside of the search sectors. These included especially large fragments and/or fragments that traveled unexpectedly long distances. For example, significant debris was found on top of and in front of magazine P-6, which is approximately 2,050 feet away from P-69 (Figure 51).

FIGURE 51. Fragment Found in Close Proximity to ECM P-6,  
Approximately 2,050 Feet Away From ECM P-69.

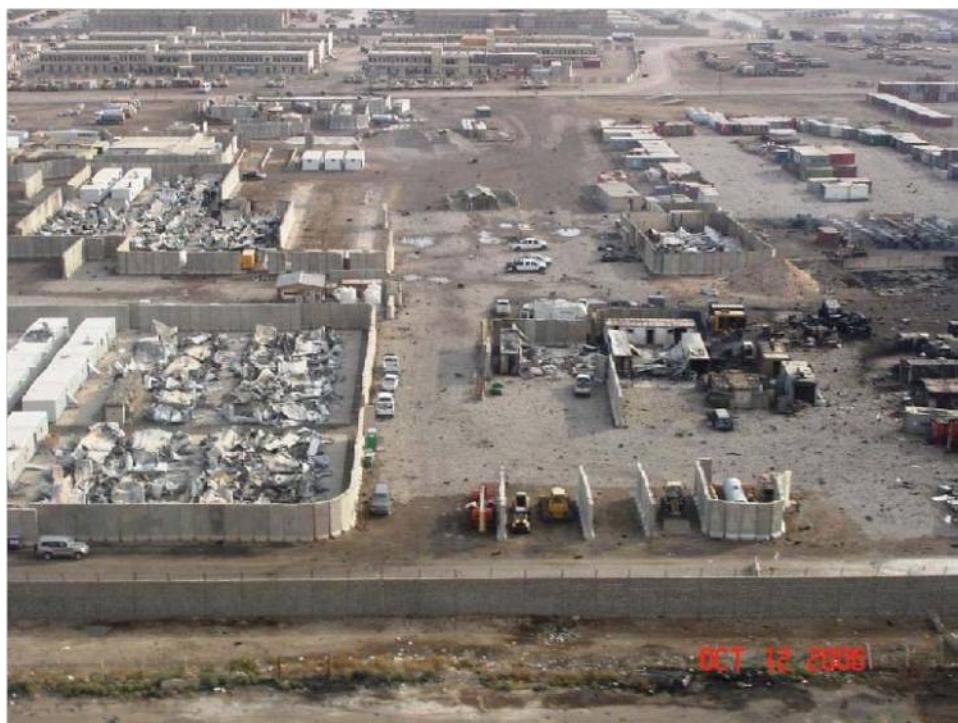
FIGURE 52. Damage at FOB Falcon Near Baghdad, Iraq, 10 October 2006.

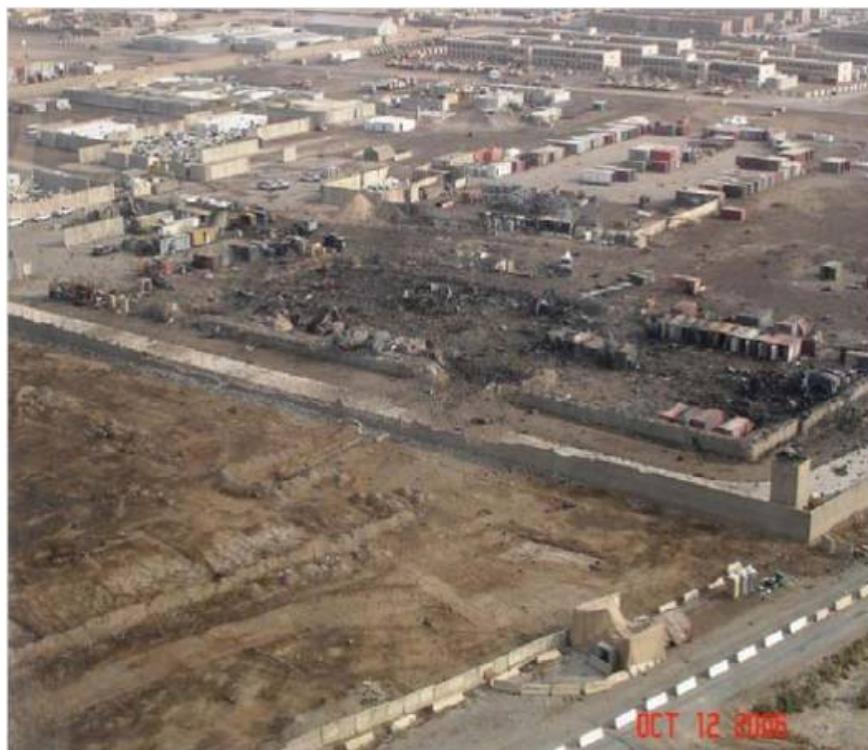
A fire started by an 82-mm mortar round fired by insurgents occurred at Forward Operating Base (FOB) Falcon near Baghdad at around 10:40 p.m. on 10 October 2006. Falcon is located in a former commercial trucking depot in a sprawling industrial area at the southern entrance to Baghdad. There were no injuries reported, but the fire spread and caused fires and explosions in surrounding tank and artillery ordnance and small arm ammunition. These fires and explosions went on for 12 hours after the original fire. The flames, smoke, and flashes from the explosions could be seen in central Baghdad, which was several miles away. There was significant damage as shown in Figures 52 and 53.

FIGURE 53. Damage at FOB Falcon, Near Baghdad, Iraq, 10 October 2006.

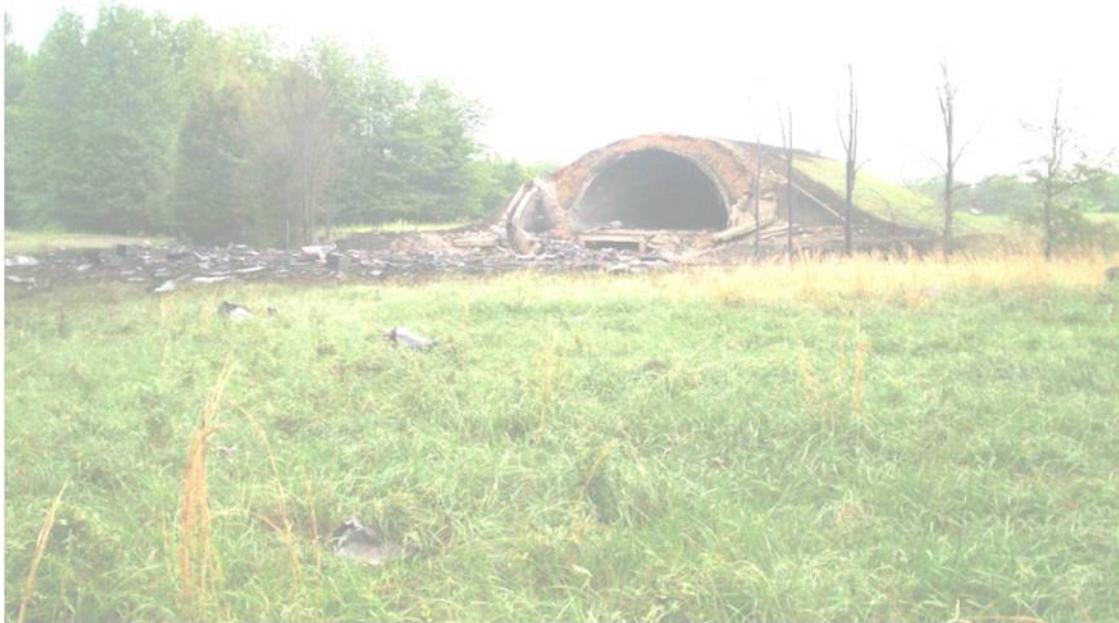
FIGURE 54. ECM With Head Wall Blown Out and Debris Scattered.

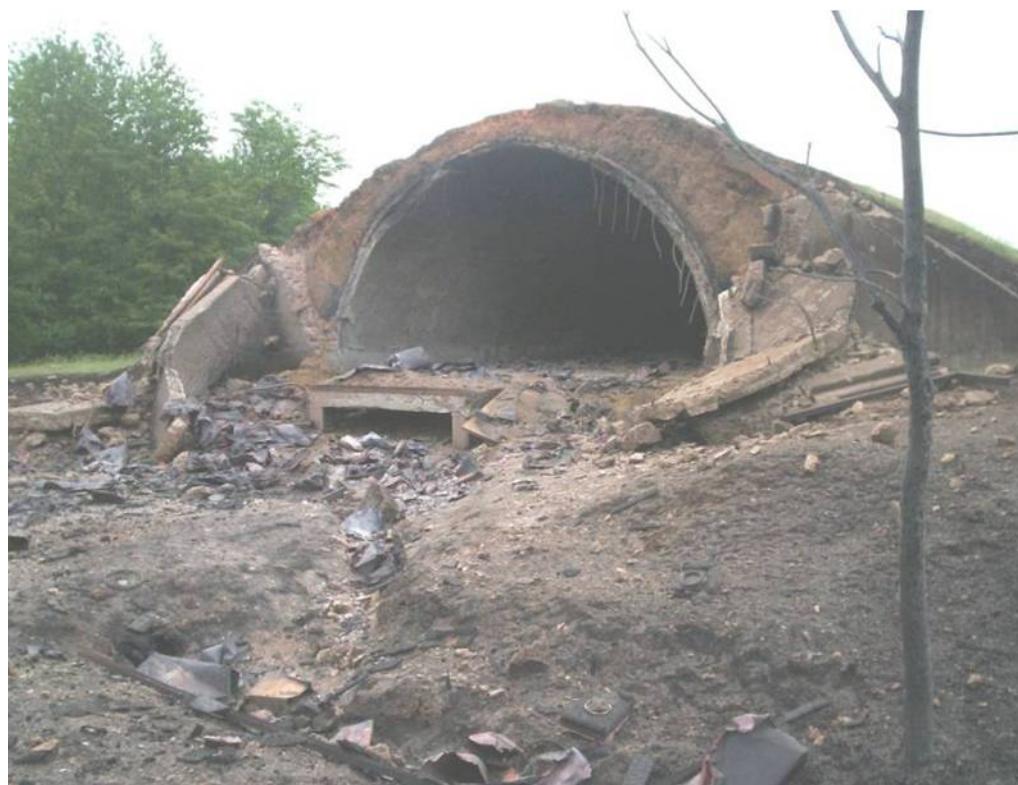
The postmortem photographs clearly show that the fire blew out the head wall and scattered debris over an area as shown in Figures 54 through 56. The remaining portion of the ECM was relatively intact as shown in the pictures. There was no evidence of cratering to indicate a detonation occurred. This is in direct contrast to description in the MSIAC accident report that had a base spokesperson saying, "At approximately 5:00 a.m., one of our storage magazines internally detonated. Something happened that caused the detonation to result in a fire." Again, there was no detonation. The fire was likely due to auto-ignition of the M-10 propellant. The fire resulted in pressurization of the magazine. Fortunately, the pressure blew out the front wall resulting in un-choked flow. The un-choked flow resulted in some material dispersed outside the magazine and burning outside as indicated in the photographs.

FIGURE 55. ECM With Head Wall Blown Out.

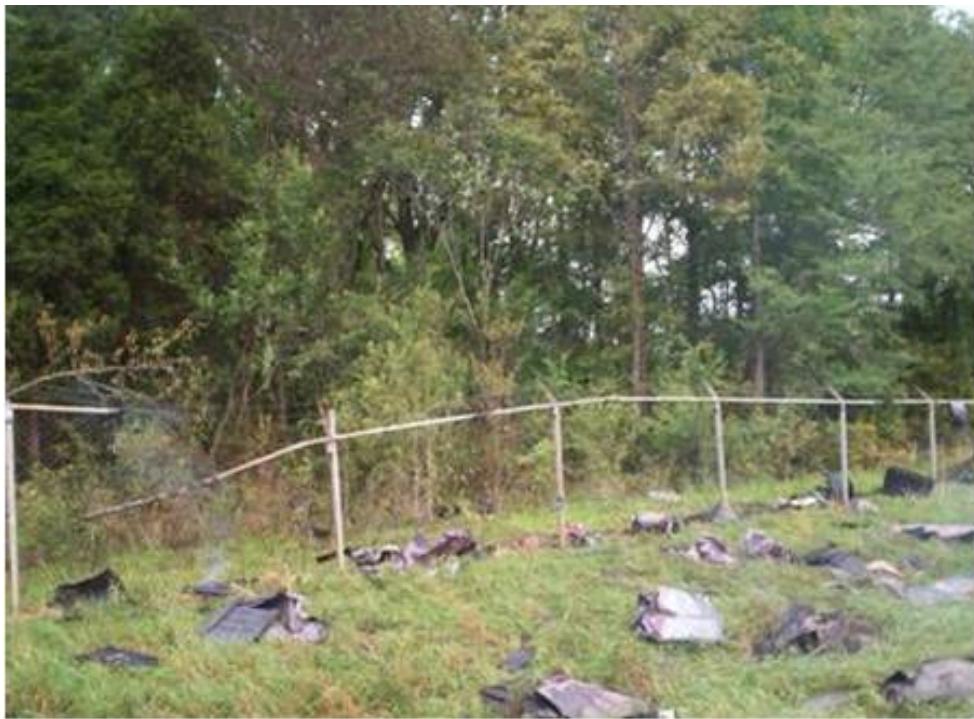
FIGURE 56. Debris Thrown From Magazine Toward Fence.

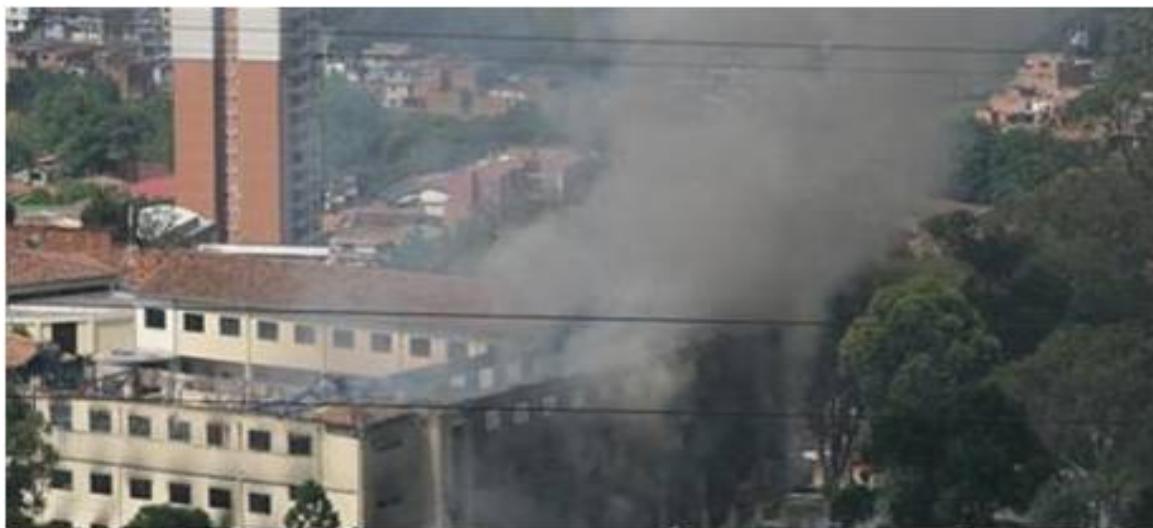
FIGURE 57. Fire at the Bombona Battalion Arsenal,  
Medellin, Colombia, 29 December 2007.

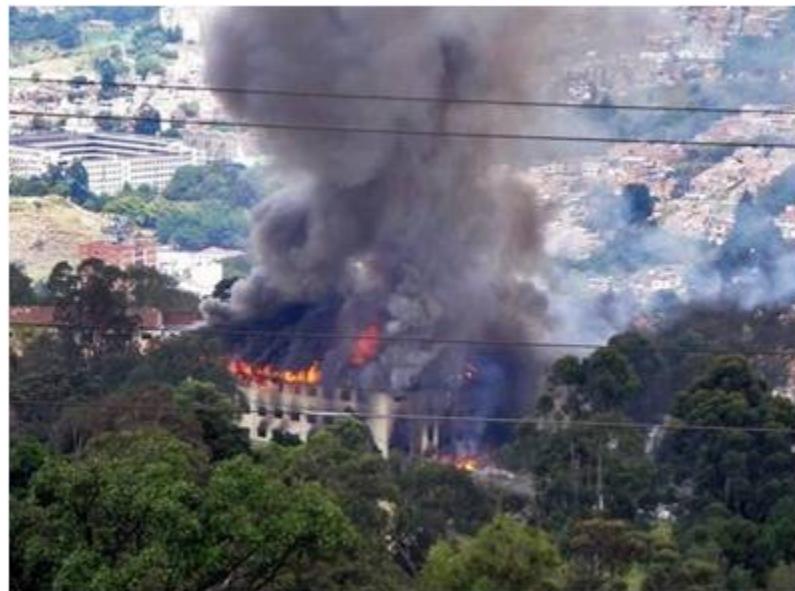
FIGURE 58. Fire at the Bombona Battalion Arsenal,  
Medellin Colombia, 29 December 2007.

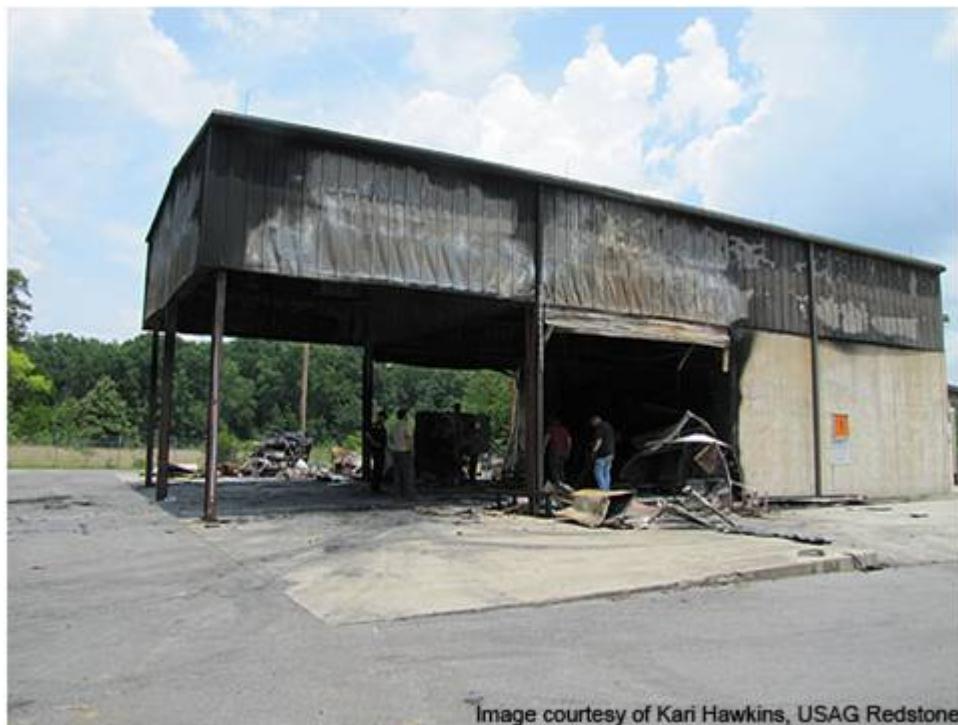
A fire broke out in Building 7298 in the Redstone Arsenal Test Center at 11:55 a.m. on 13 July 2010. No one was hurt and everyone was accounted for. Flames caused partial damage to the building but firefighters worked quickly to keep the damage from spreading. While the fire was contained, it was allowed to smolder until the next day. There were no explosions. The cause of the fire was unknown. On 15 July, it was reported that Redstone Test Center personnel were conducting a Hellfire missile test at the time the fire was reported. Figure 61 shows the damage from the fire to Building 7298.

FIGURE 61. Damage to Building 7298, Redstone Arsenal,  
Due to Fire on 13 July 2010.

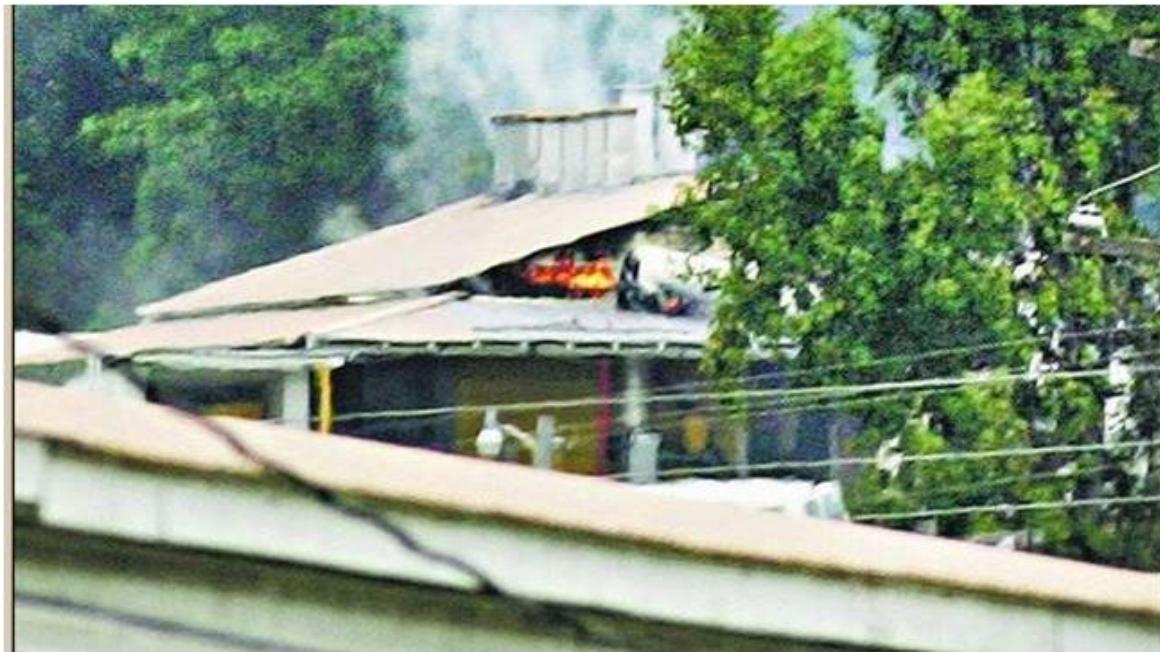
FIGURE 62. Fire in Building 35, Kilgore Flares Company, 14 September 2010.
